Repairing Dell U2711 Display Flickering Panel due to corroded Contacts

Written By: Jeho

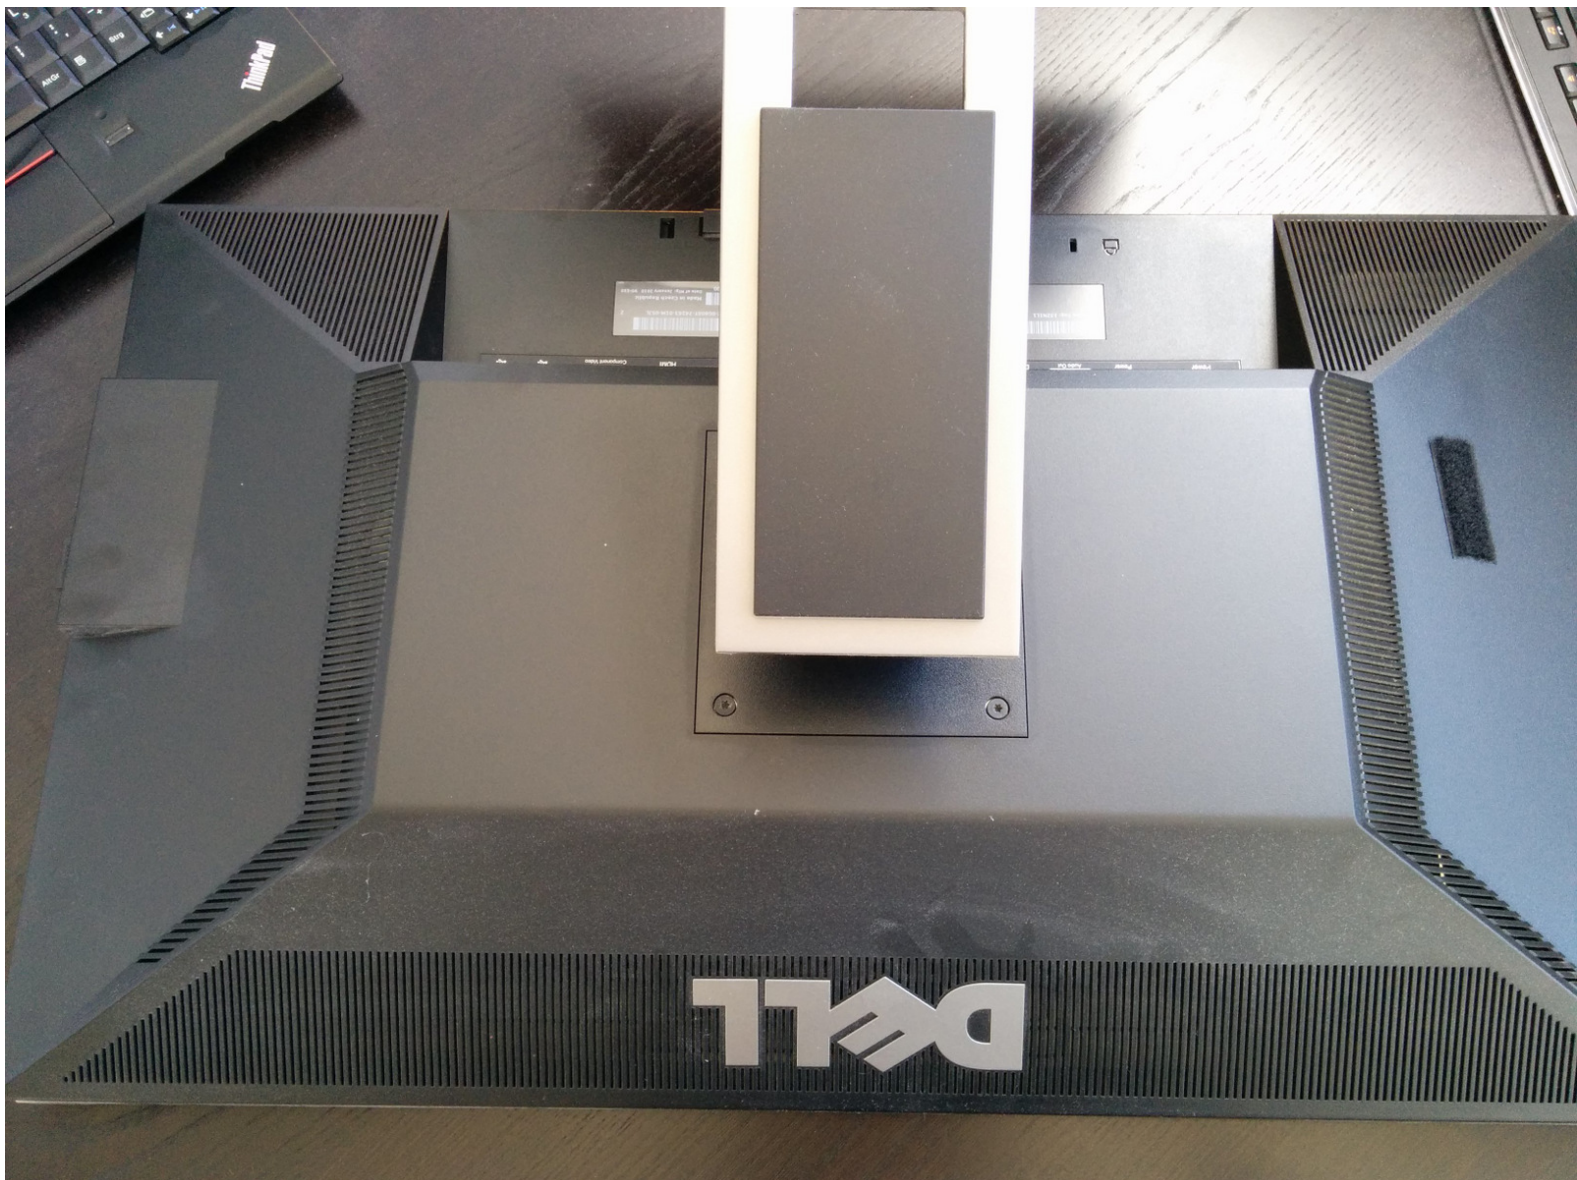
The Dell U2711 Monitor has a problem with unstable contacts due to corrosion. The symptom is a flickering screen. Knocking on the top of the monitor can make this symptom go away for a while, but a longer term solution is to clean the contacts.

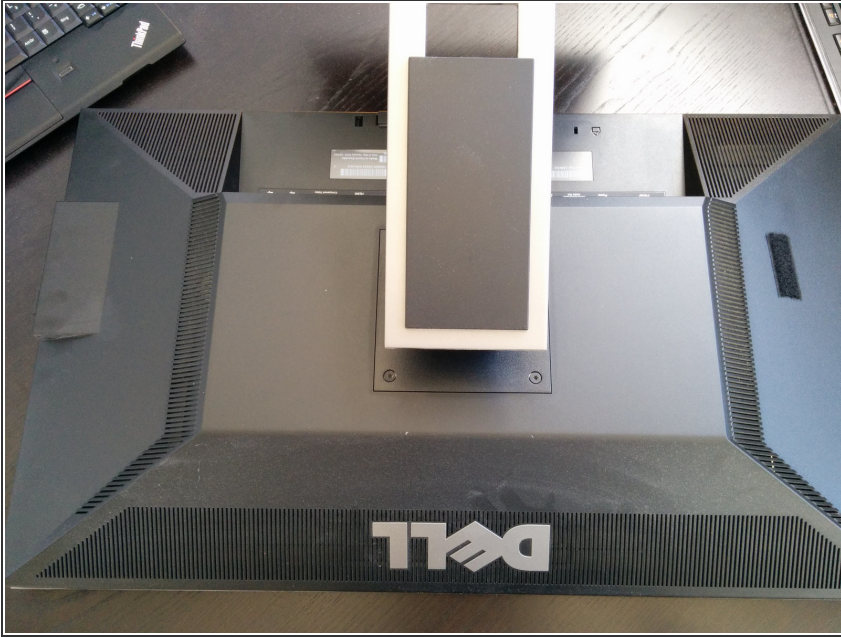
Step 1 — Unmount Display Stand

- Lay the display on a desk with the front facing down. Best use a towel to save the desk and display from scratching.
- Unscrew the four hex screws that secure the stand.

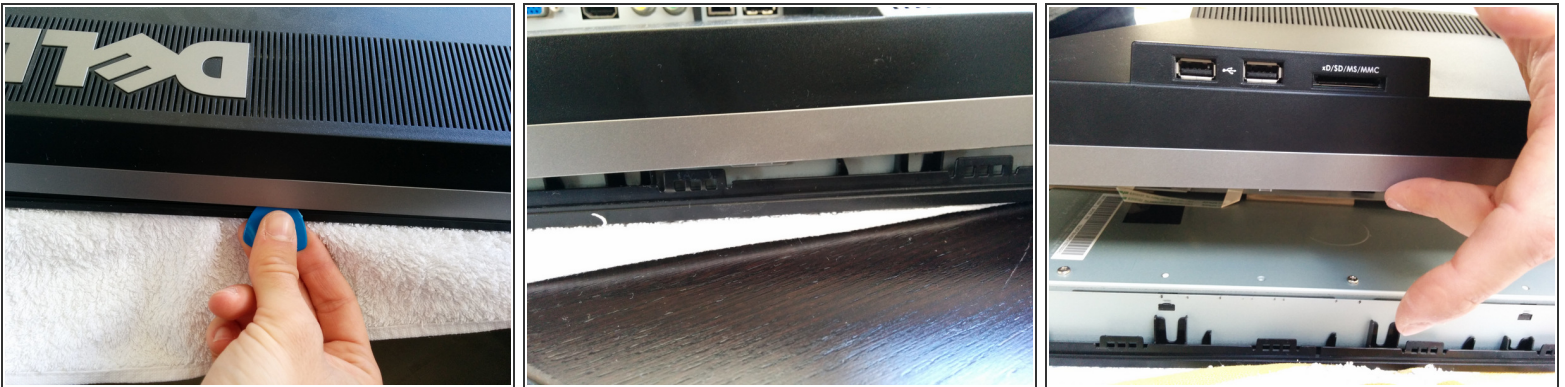
Step 2

- Starting opposite of the buttons, pray open the display bezel with a plectrum.
- You have to apply some force.
- Don't lift the rear panel higher than two centimeters. There are delicate flat cables on the button side which might be damaged.
- Be extra careful at the buttons, you don't want to damage a cable.

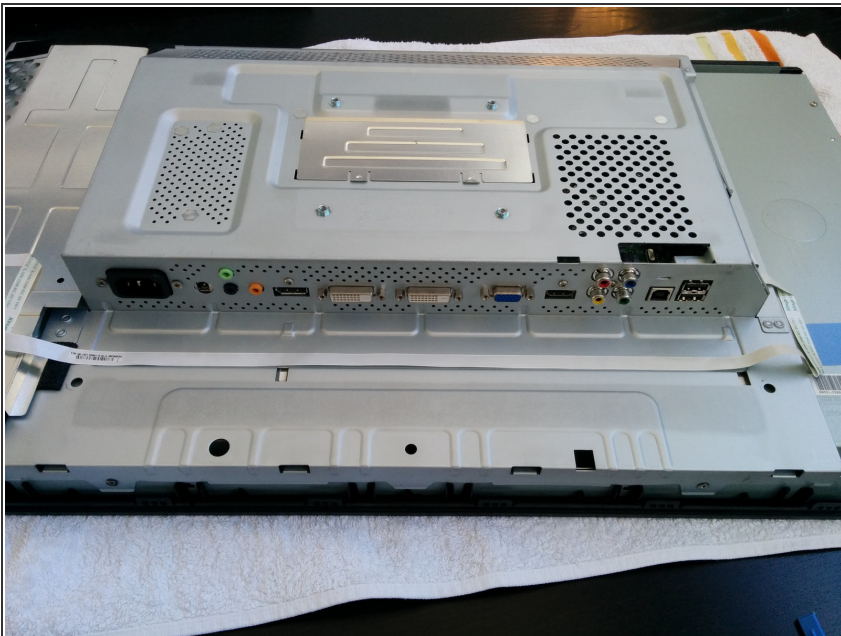
Step 4 — Remove Cover

- Remove the shiny cover in the middle.

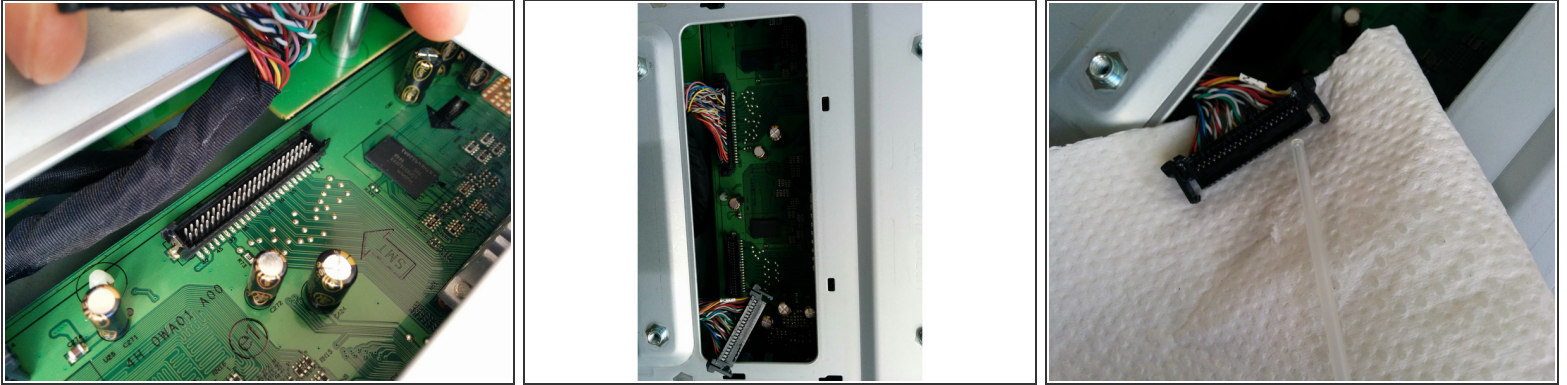
Step 5

- There are two black connectors below the cover.
- Unplug both and treat with contact spray.
- Plug both back in.
- Reassemble the display.
- You should be fine for a while. Notice that the corrosion might return in a few months.
